Analysis of KARI Corner Reflector in Mongolia Site for KOMPSAT 6 Calibration and Image Quality Measure

Korea Aerospace Research Institute Horyung Jeong, Dochul Yang, Woosung Park, and Doochun Seo

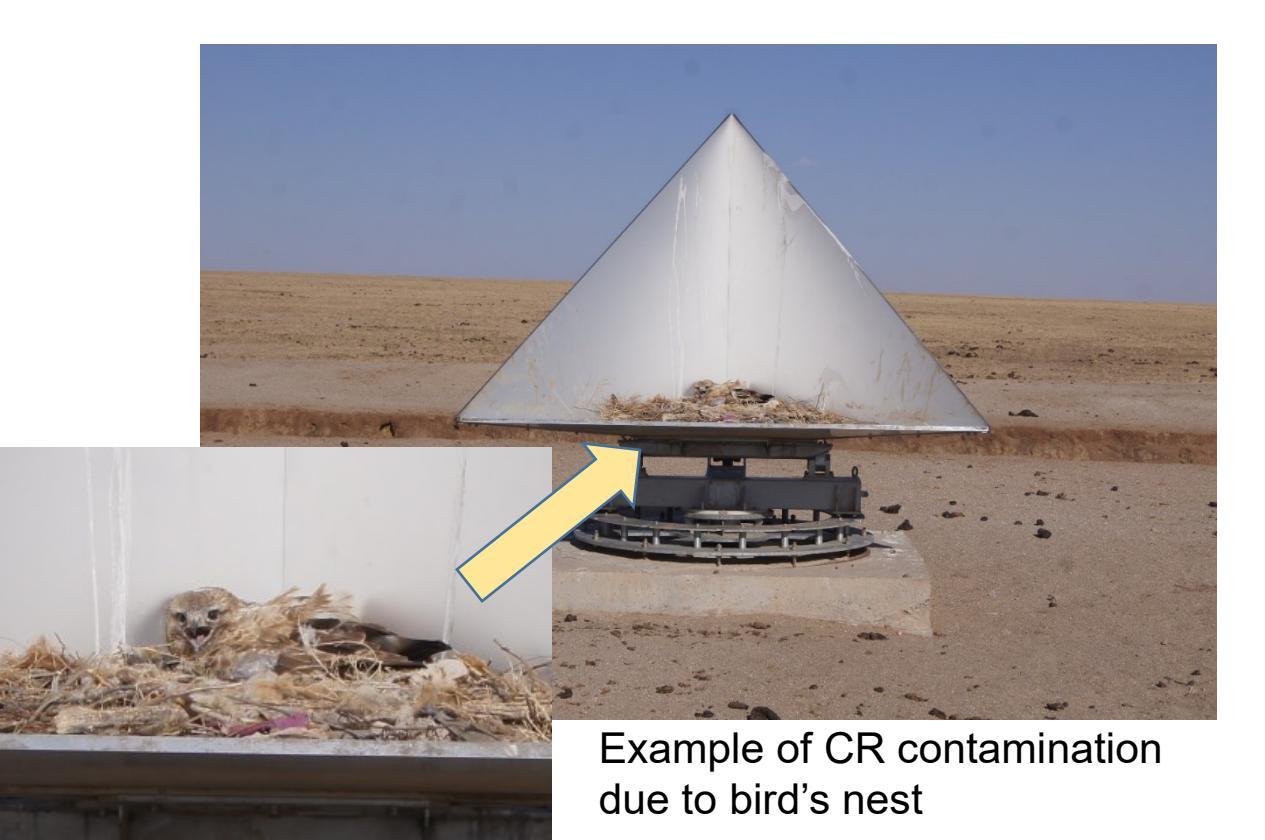
- Examples of Maintenance for Mongolia Site SAR Calibration Targets (2019)
  - The CR is unable to perform its proper target function due to a bird's nest.
  - The CR is unable to perform its proper target function due to a pile of garbage accumulated by locals.

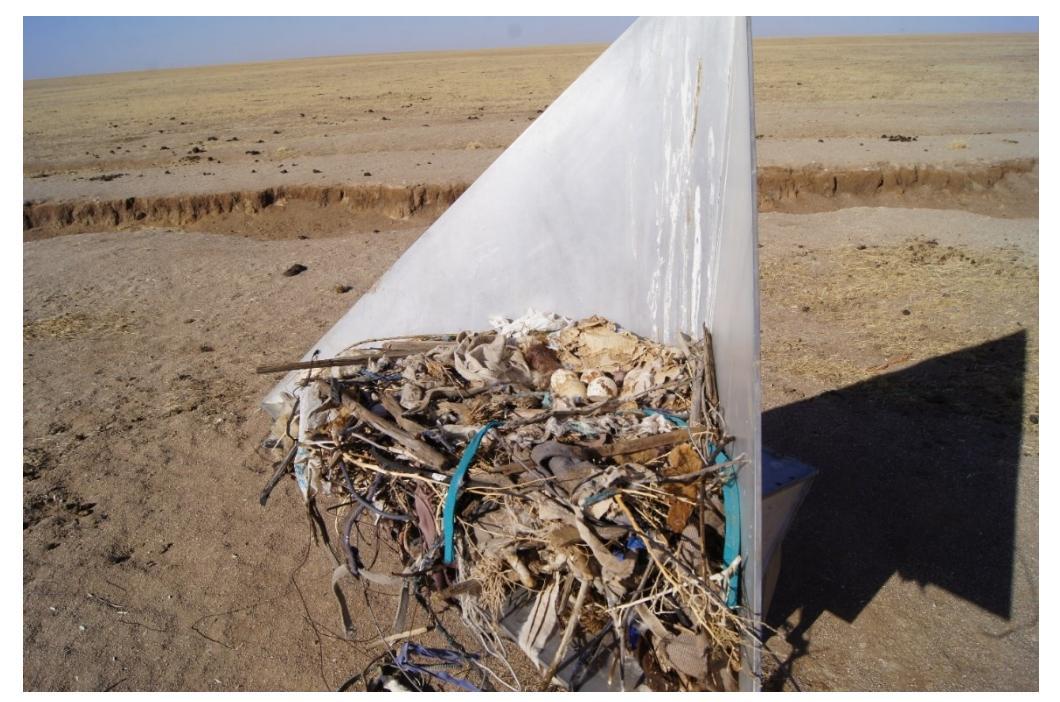
Example of CR contamination due to a pile of garbage

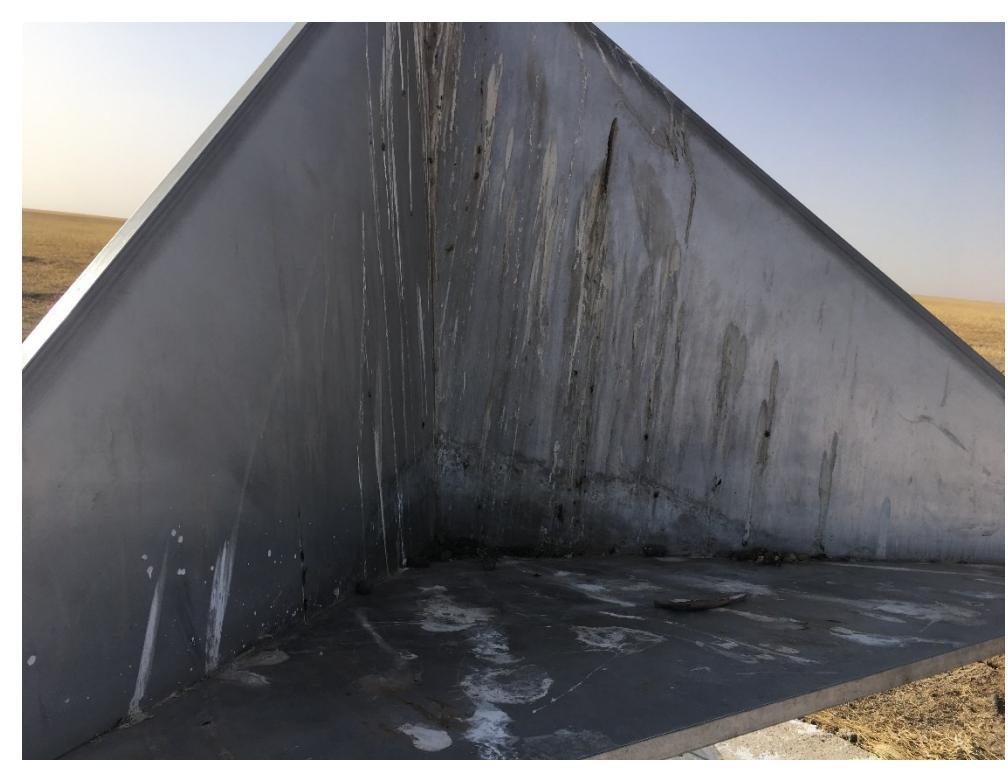
- **Examples of Maintenance for Mongolia Site SAR Calibration Targets (2019)** 
  - Due to aging, the surface coating has peeled off, revealing black stains.
  - Due to aging, the azimuth angle adjuster has rusted and is unable to function properly.

Aging of the surface condition

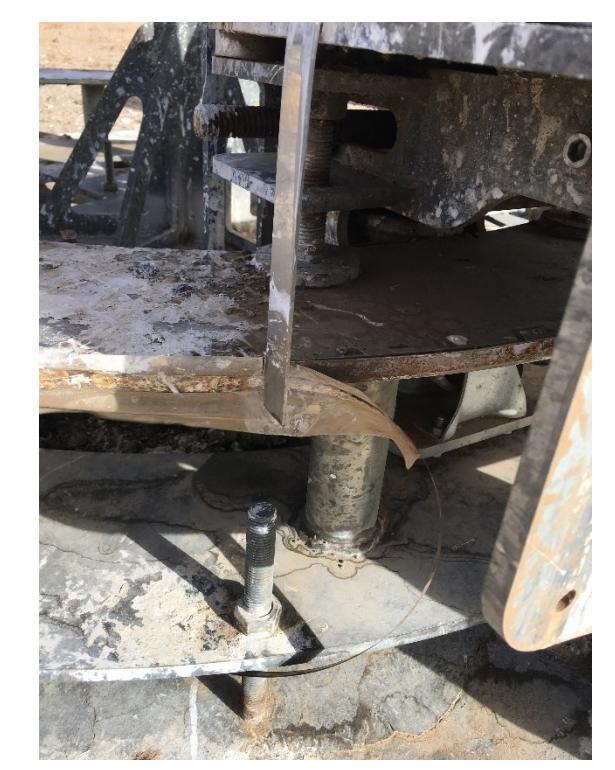
Aging of the angle adjuster
