Analysis of KARI Corner Reflector in Mongolia Site for KOMPSAT 6 Calibration and Image Quality Measure

Korea Aerospace Research Institute Horyung Jeong, Dochul Yang, Woosung Park, and Doochun Seo

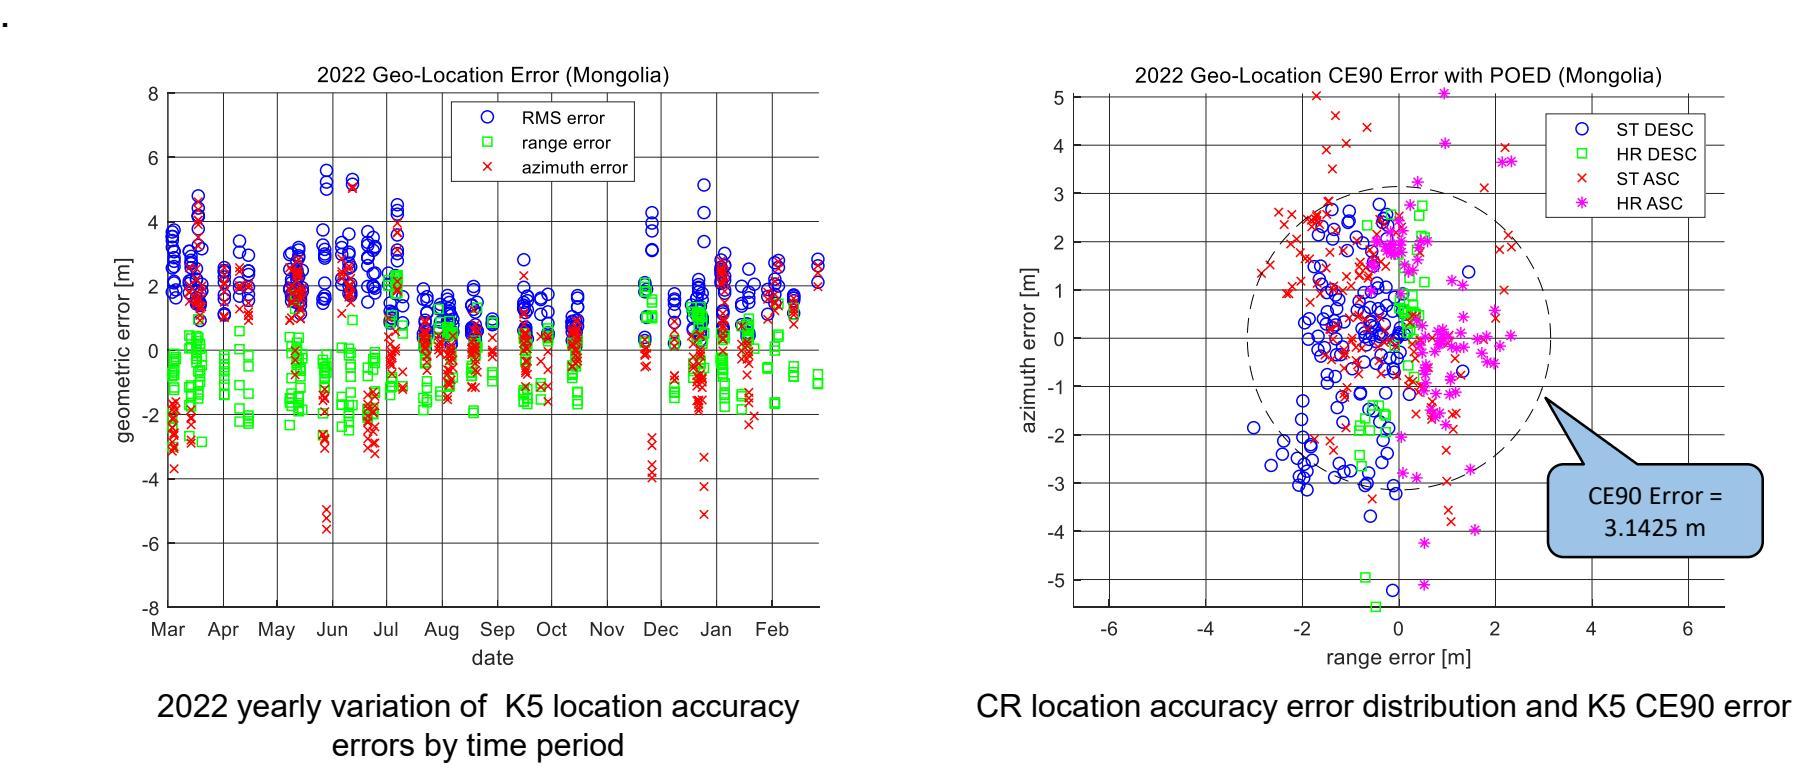
- Using Mongolia region CR images taken from March 2022 to February 2023.
  - Measurement results affected by orbit adjustments, weather, etc., were excluded from the analysis.
- It was confirmed that the K5 location accuracy remained stable without an increasing trend over time.
- The CE90 error is 3.1425m, which sufficiently complies with the K5 requirements.

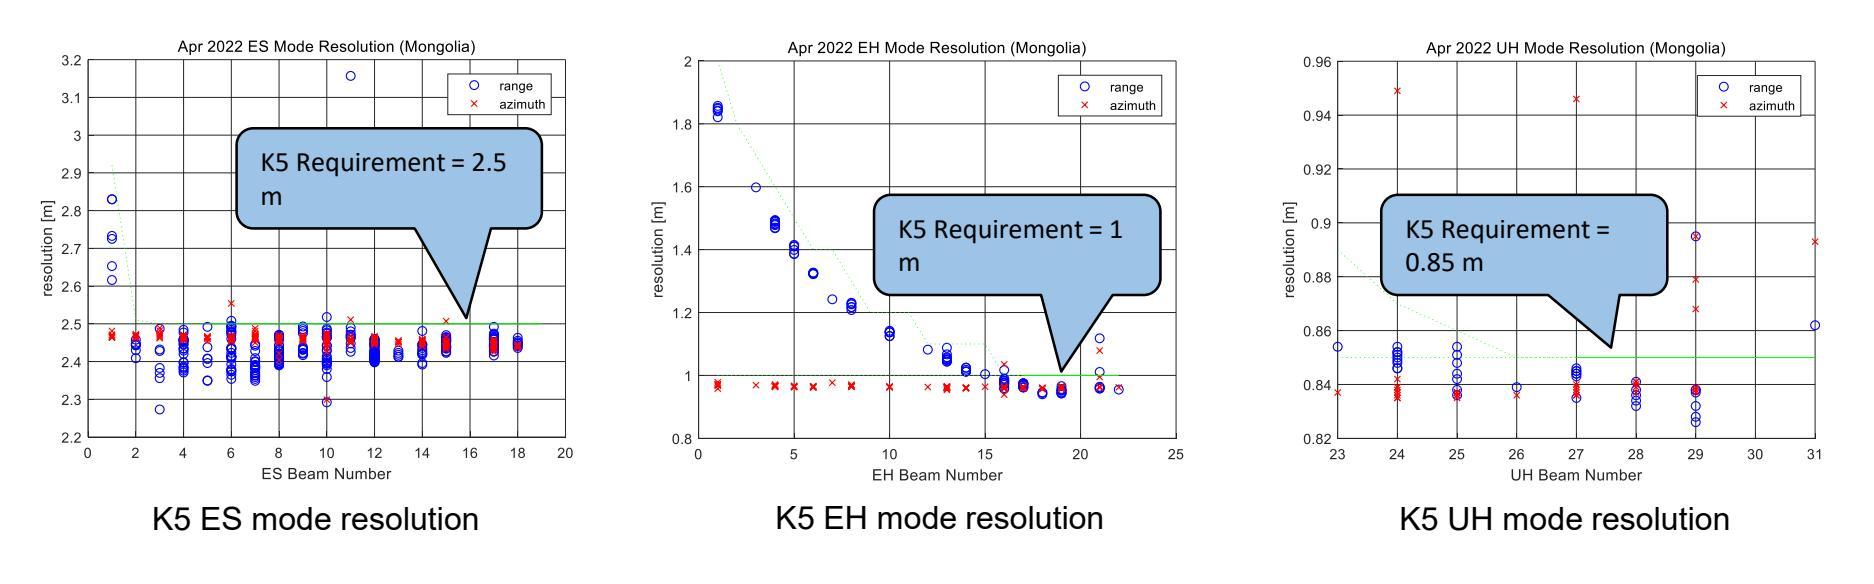
- Using Mongolia region CR images taken from March 2022 to February 2023.
- Almost all measurement results, except for a few, meet the K5 requirements.
  - For ES-05 to ES-19, within 2.5m.
  - For EH-17 to EH-31, within 1m.
  - For UH-27 to UH-31, within 0.85m.
- Cases that did not comply with the requirements are expected to be caused by environmental factors of the Mongolia CR (snow, rain, or cleaning conditions).
- The Near Side beam, which is not defined in the requirements, also satisfies the design specifications.
  - The dotted line in the figure represents beams defined outside the requirements.

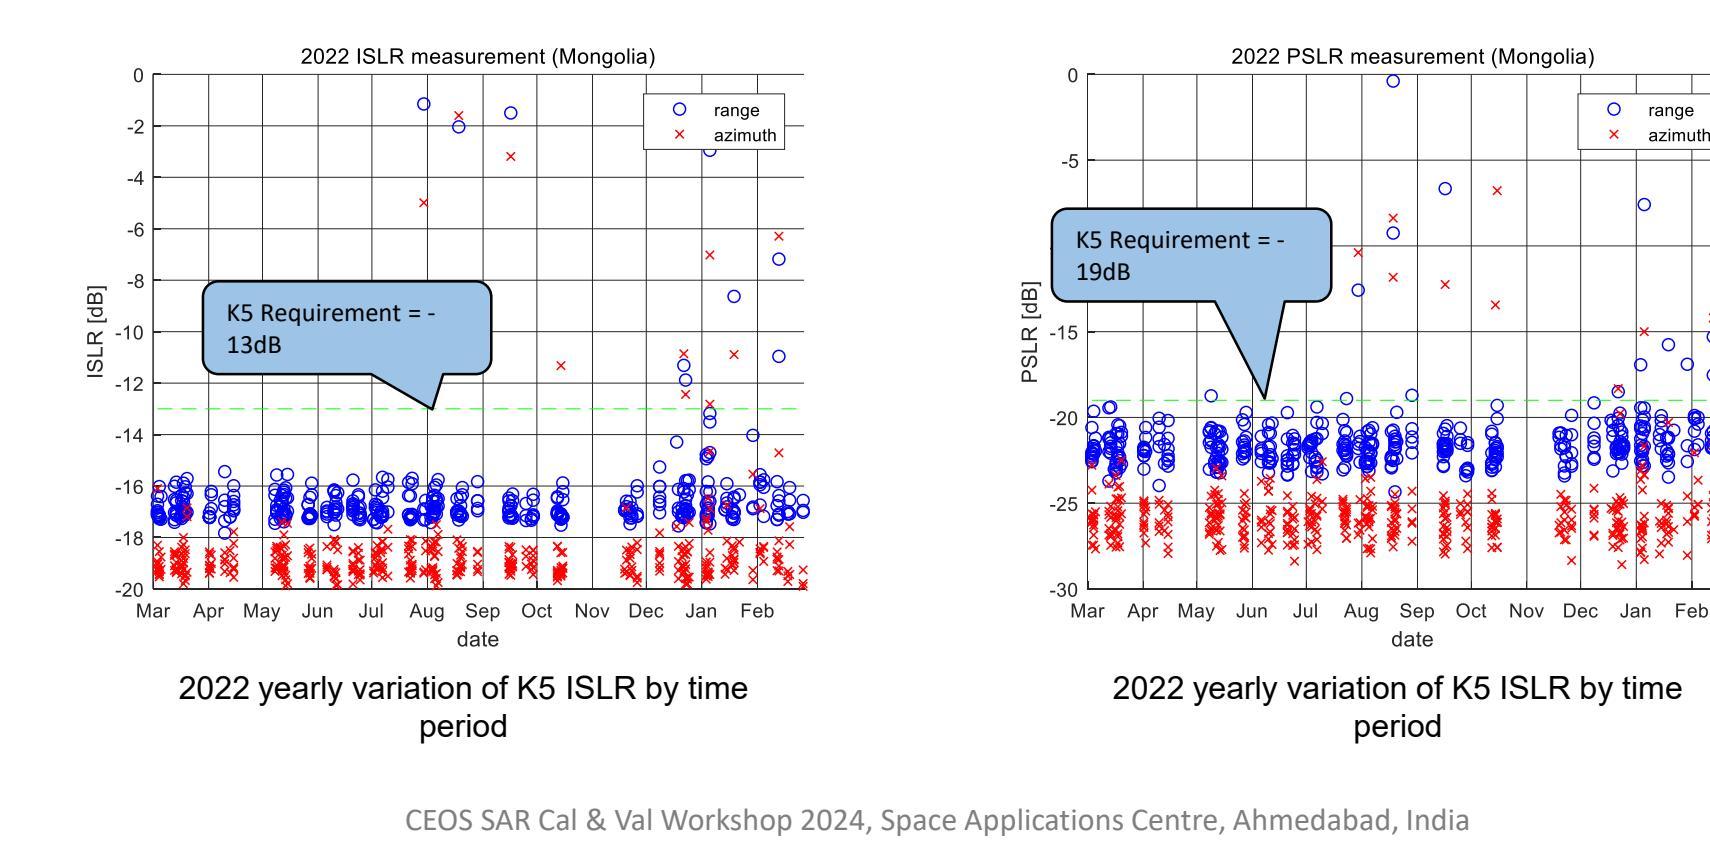
- Using Mongolia region CR images taken from March 2022 to February 2023.
- The majority of cases, except for a few, meet the K5 requirements.
  - K5 requirements = ISLR below -13dB, PSLR below -19dB.
- Cases that did not comply with the requirements are expected to be caused by environmental factors of the Mongolia CR (snow, rain, or cleaning conditions).

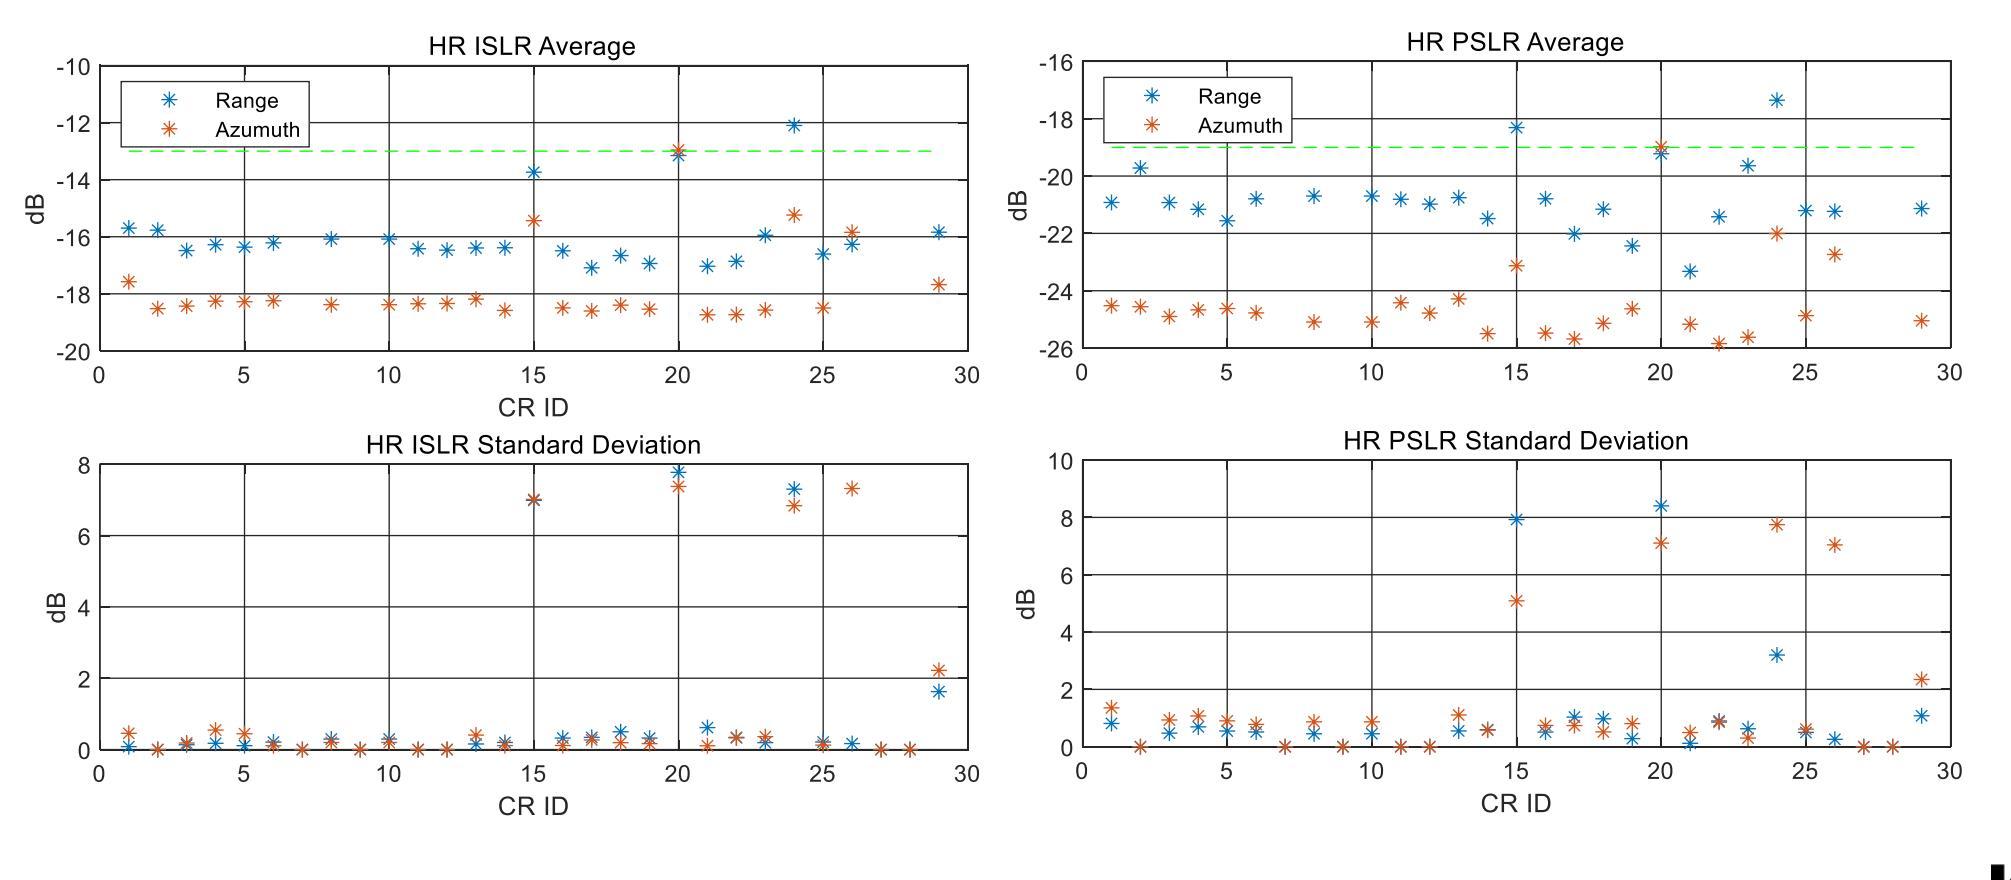
- The ISLR of the HR CR is approximately -16 dB for range and about -18 dB for azimuth
- The PSLR is approximately -21 dB for range and about -25 dB for azimuth.
- The standard deviations of the ISLR and PSLR for HR CRs generally show quite stable values
  - Unstable standard deviation are expected to indicate that the CR is not functioning properly due to external factors.

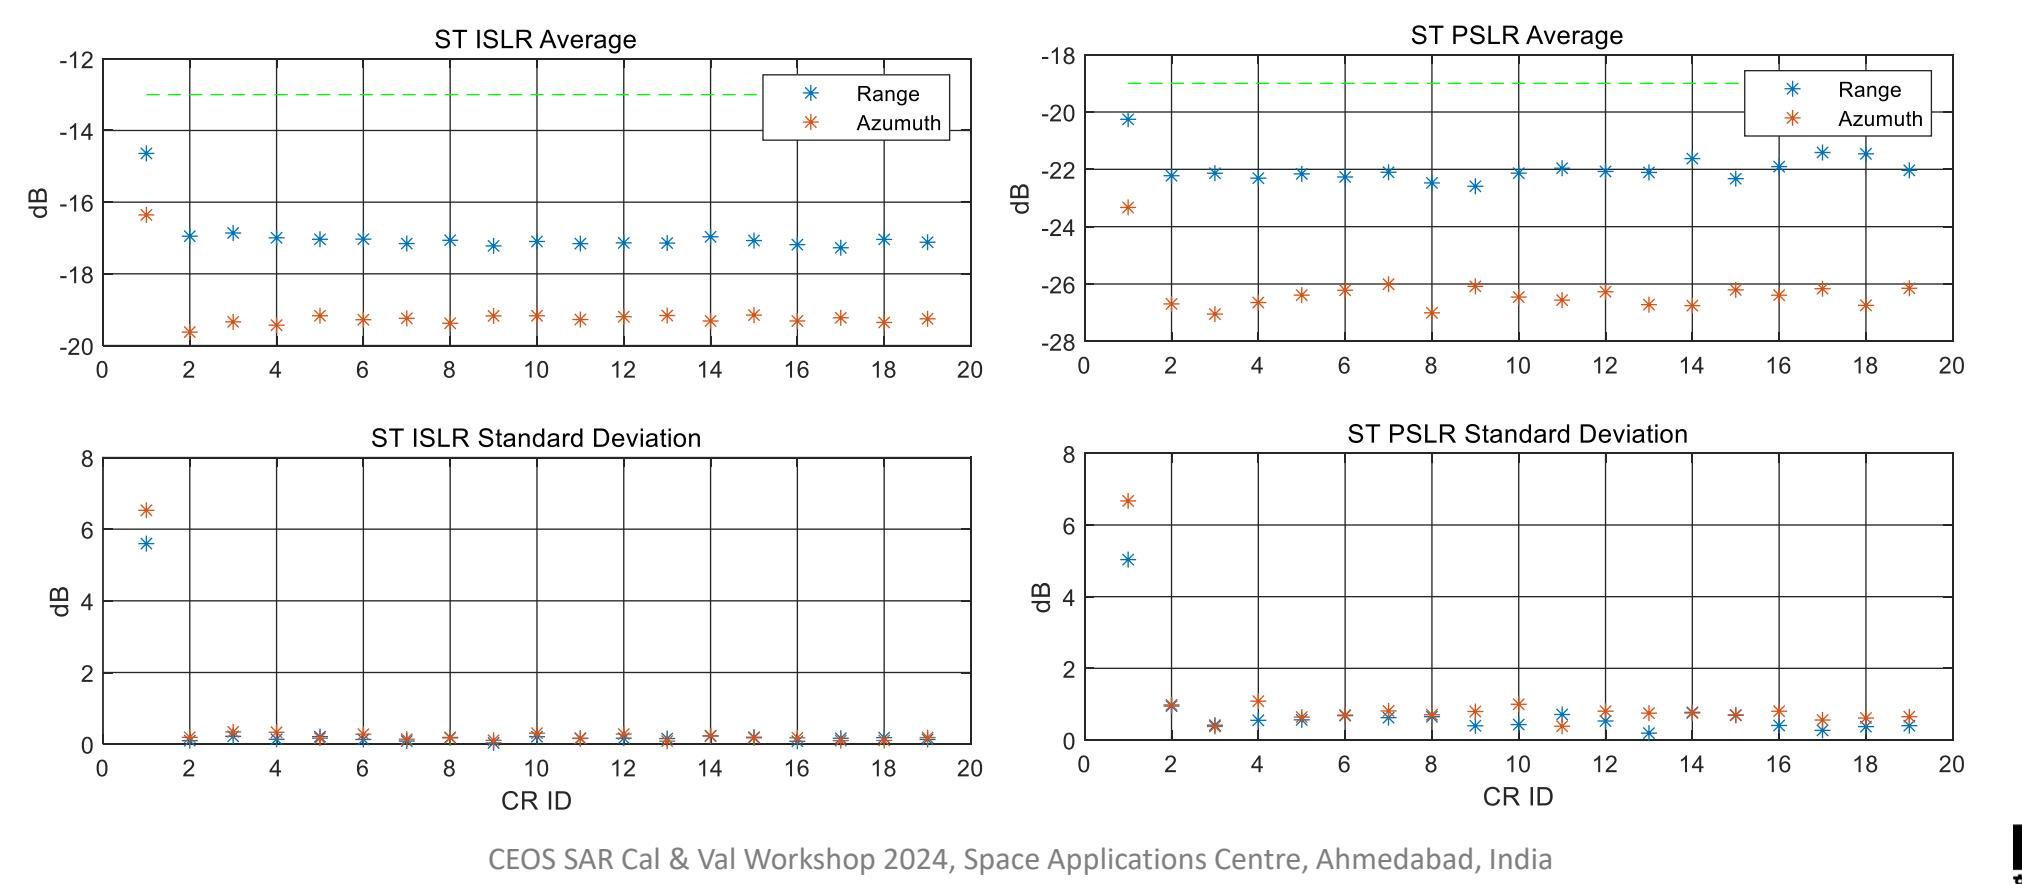
- The ISLR of the HR CR is approximately -17 dB for range and about -19 dB for azimuth
- The PSLR is approximately -22 dB for range and about -29 dB for azimuth.
- The standard deviations of the ISLR and PSLR for HR CRs generally show quite stable values, too
- The reason the ISLR/PSLR of the ST CR is lower than that of the HR CR is likely due to the relatively larger size of the ST CR, which results in a higher RCS and consequently a more stable signal-to-clutter ratio

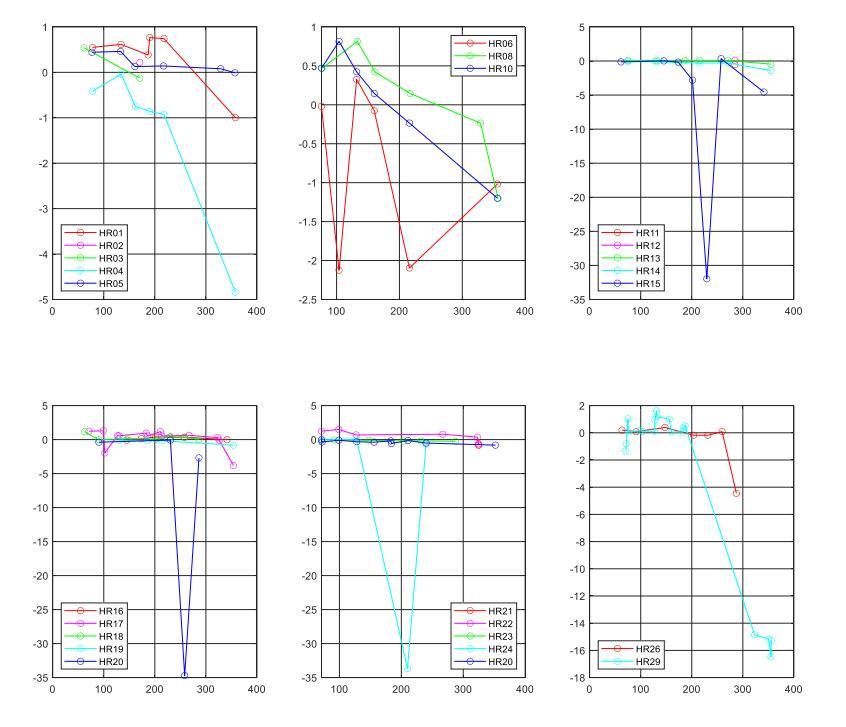
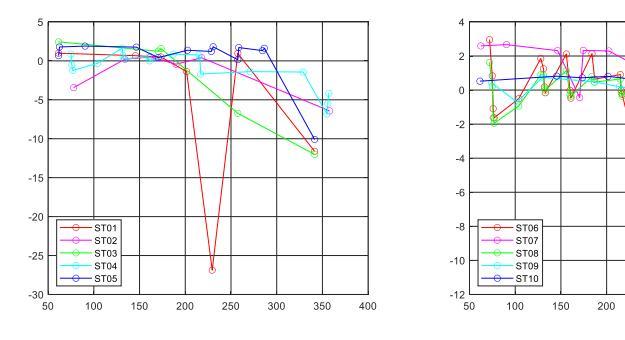
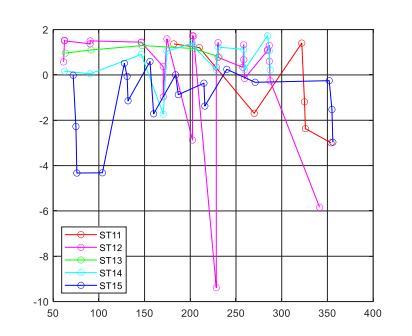
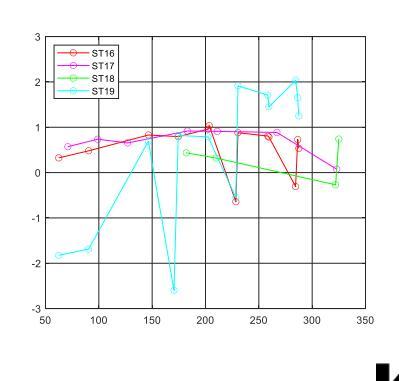
- Radiometric Error vs. Time Graph for Each CR
  - The six graphs summarize the Radiometric Error measurement results for 52 ST and 20 HR CRs, divided into groups of five.
    - The results of the CRs with significantly low radiometric error measurements were excluded from the graph
  - As shown in each graph, some CRs exhibit significant changes in Radiometric Error over time, while others maintain a stable Radiometric Error regardless of the time.
  - By examining these graphs, we will categorize the CRs that demonstrate stable Radiometric Error and plan to use them for K6 calibration.

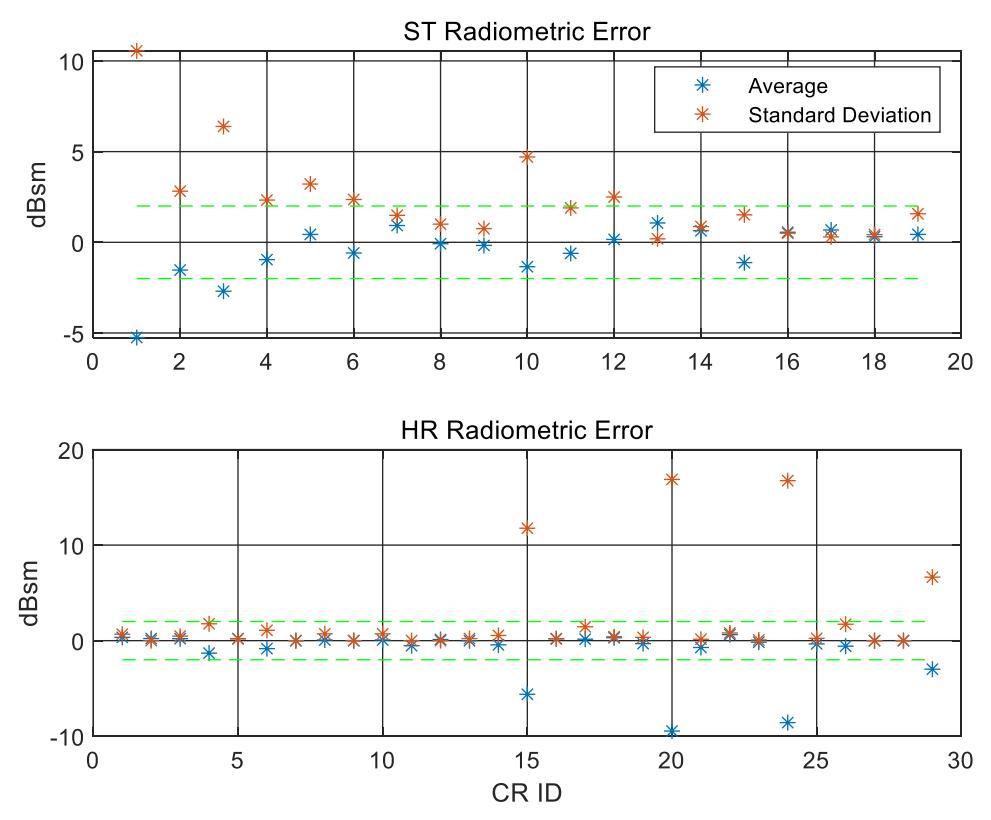
- Summary of Radiometric Error Measurements from Mongolia Corner Reflectors
  - Using Mongolia CR images taken from March 2022 to February 2023.
  - Almost all measurement results, except for a few, meet the K5 requirements.
  - Cases that did not meet the requirements are expected to be caused by environmental factors of the Mongolia CR (snow, rain, or cleaning conditions)
